**Flood Control Project Maintenance
Levee Inspections**
LMA District Cover Sheet
Spring 2019 Levee Inspection Results

Sutter Maintenance Yard East Levee Sacramento River

Spring 2019 Levee Inspection Results

Levee Inspection Report By Mile - Spring 2019

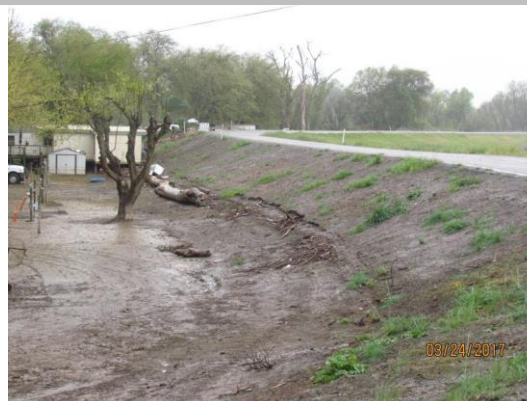
Photo 1 of 1 : SP_2019_ST0003_264_130_20190327_00032.jpg

LM Start	0.11	Rating **	M	Issue No.	130
LM End	0.14	Issue Type +	Ma	Location *	WS
Category	Earthen Levee			GPS Latitude/Longitude	
				Start	End
Item	Slope Stability			39.195163 °	39.195038 °
				-121.936815 °	-121.937435 °
DWR ID	DWR_ST0003_01_s _ 2017_130				
Comment Code					
S1 : Repair slope instability.					
Inspector Comment					
Repair the erosion along the waterside slope.

View of the erosion along the waterside slope.

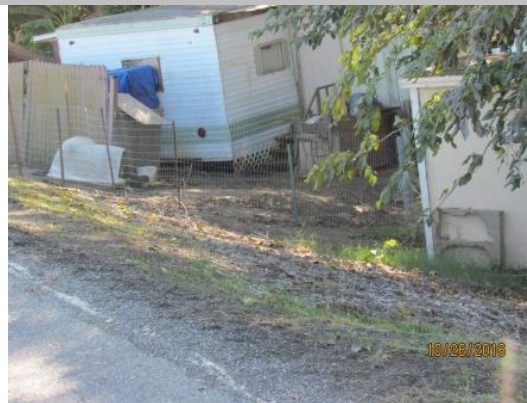
Photo 1 of 1 : SP_2019_ST0003_264_3_20190327_00003.jpg

LM Start	0.15	Rating **	U	Issue No.	3
LM End	0.20	Issue Type +	En	Location *	WS
Category	Earthen Levee			GPS Latitude/Longitude	
				Start	End
Item	Encroachments			39.194978 °	39.195022 °
				-121.937502 °	-121.938563 °
DWR ID	DWR_ST0003_01_s_2012_3				
Comment Code					
BU : Building					
Inspector Comment

View of the trailers and building on the waterside.

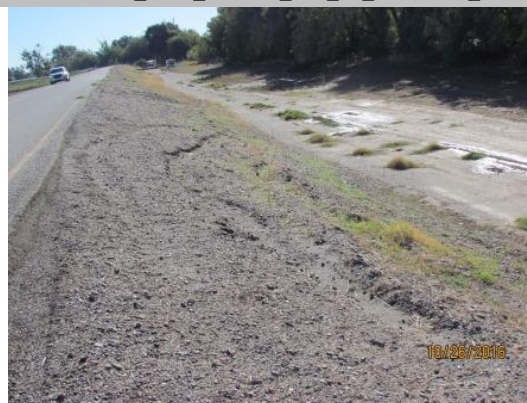
Photo 1 of 1 : SP_2019_ST0003_264_81_20190327_00018.jpg

LM Start	0.42	Rating **	M	Issue No.	81
LM End	0.42	Issue Type +	Ma	Location *	WS
Category	Earthen Levee			GPS Latitude/Longitude	
				Start	End
Item	Slope Stability			39.196483 °	39.196483 °
				-121.942228 °	-121.942228 °
DWR ID	DWR_ST0003_01_f_2016_81				
Comment Code					
S3 : Repair the levee slope damaged by vehicle traffic and prevent access where possible.					
Inspector Comment

View of the ruts along the waterside slope.

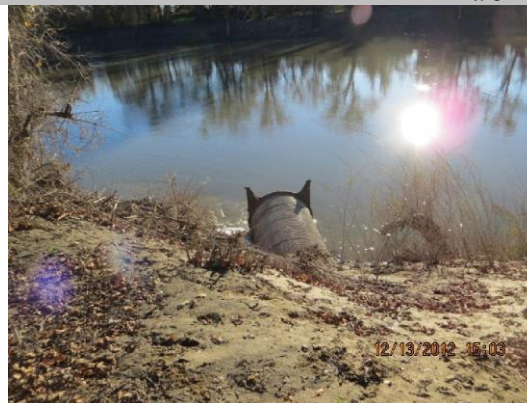
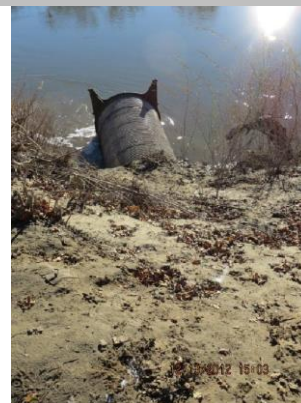
FS_ID:51650
DS_ID:17307
EP_NO: 9534
Repair Type: No Action Needed
Crossing Status: Found
UCIP Comments: 10/27/2017 This structure is inspected annually under the Structure and Channel Summer Inspection (part of the Levee Inspection Program) conducted by the DWR Flood Project Integrity and Inspection Branch (FPIIB). (DWR UCIP - O. Magana)
4/24/2017 Both sides of crossing were underwater during site visit. Will need to revisit after water levels drop. (DWR Sutter Yard- A Freitag) 11/7/2016 Crossing appears to be in good condition. (DWR Sutter Yard- A Freitag) 6/6/2016 Crossing appears to be in good condition. 4/6/2015 Good Condition. No issues. Semi circle CMP half riser in inlet structure on LS. Inlet opening has no trash rack, this may cause safety issue. 6/30/2014 Same as last inspection. 12/30/2013 Same as last inspection. 7/29/2013 Same as last inspection.
FIELD_STRUCT_DESC: [Butte Slough Drainage Structure] 78-inch drainage pipe of an unknown material through the levee, 3 feet below the crown. Flap gate on the waterside (WS). Corrugated metal pipe (CMP) half riser (in a semi-circle configuration) in the inlet structure on the landside (LS). (78-inch pipe [HLM 0.44] authorized under Automatic Board Order (ABO) issued as Permit No. 9534, 1974 - Caleta).

Waterside view: overview towards CMP sewer pipe

Waterside view: water flowing from CMP sewer pipe

Landside view: overview

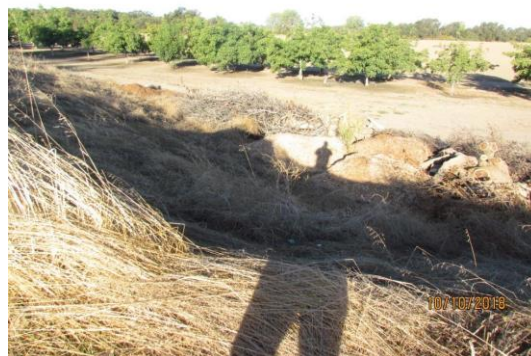
Photo 1 of 1 : SP_2019_ST0003_264_93_20190327_00020.jpg

LM Start	0.74	Rating **	M	Issue No.	93
LM End	0.74	Issue Type +	En	Location *	LS
Category	Earthen Levee			GPS Latitude/Longitude	
				Start	End
Item	Encroachments			39.198310 °	39.198310 °
				-121.947463 °	-121.947463 °
DWR ID	DWR_ST0003_01_f_2018_93				
Comment Code					
PR : Prunings					
Inspector Comment					
The prunings should be removed from the landside slope and toe.

View of the prunings along the landside slope and toe.

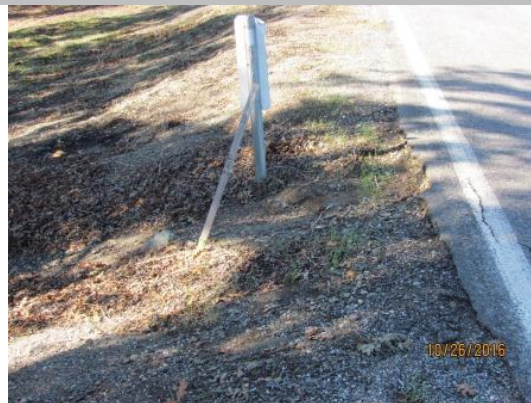
Photo 1 of 1 : SP_2019_ST0003_264_80_20190327_00017.jpg

LM Start	1.17	Rating **	M	Issue No.	80
LM End	1.17	Issue Type +	Ma	Location *	WS
Category	Earthen Levee			GPS Latitude/Longitude	
				Start	End
Item	Slope Stability			39.194126 °	39.194126 °
				-121.953345 °	-121.953345 °
DWR ID	DWR_ST0003_01_f_2016_80				
Comment Code					
S1 : Repair slope instability.					
Inspector Comment

View of the slope instability along the waterside slope.

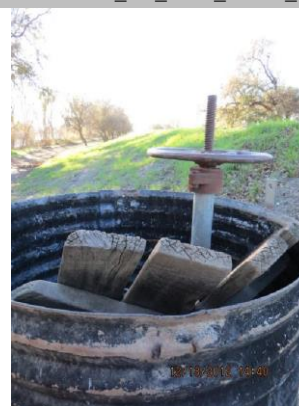
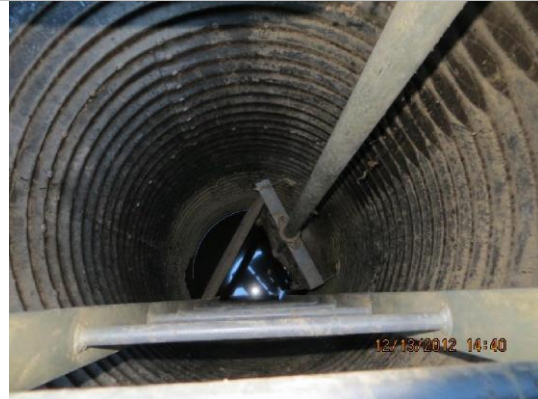
Comment Code					
Inspector Comment					
FS_ID:53399 DS_ID:17319 EP_NO: 9527 Repair Type: Urgent Crossing Status: Found UCIP Comments: 8/30/2018 WS vegetation completely overgrown towards walkway and pump so could not inspect. WS pipe end is nearly completely covered in debris, pipe cap appears either open or broken, LS erosion still present, and pipe end completely covered in debris so crossing remains Urgent (D. Sanoski - DWR UCIP).4/24/2017 LS slope damage is still present. No repairs have been made to this crossing yet. (DWR Sutter Yard- AFreitag)11/7/2016 No LS repairs have been made yet. (DWR Sutter Yard- AFreitag)6/6/2016 New flow meter installed on WS. Walkway to access the pump is overgrown with vegetation and not accessible. (DWR Sutter Yard - afreitag) 4/5/2016 Caved-in slope on landside (LS) not yet repaired. Leaky pipe marker gone. Per Bob Duffey (DWR FPIIB inspector), pipe will be replaced by owner next year. If not, will go to CVFPB enforcement. (DWR UCIP - kfazel)4/6/2015 Pipe leaks during times of High water. Slope damage still present. Needs a more detailed inspection to find the leak. (DWR Sutter Yard - afreitag)6/30/2014 Same as last inspection. (DWR Sutter Yard - afreitag)12/30/2013 Same as last inspection. (DWR Sutter Yard - afreitag)7/29/2013 Pipe does not appear to be abandoned. On the WS it appears that a smaller pipe was sleeved into the 18in. Pipe and then the difference capped and welded. Pump was not running at time of inspection but LS ditch near outlet was wet. LS slope damage and leaky pipe marker are still present. (DWR Sutter Yard - afreitag)12/13/2012 Abandoned and plugged/capped steel pipe on WS berm. DWR leaky pipe marker on LS (12-3). Slope failure on LS. Needs capping of LS steel pipe after detailed investigation. (DWR UCIP - pamatya) FIELD_STRUCT_DESC: 18-inch steel irrigation pipe through the levee, 12.5 feet below the crown. Gate valve on the waterside (WS). Vertical pump on the WS bank. Flow meter on the WS. (Automatic Board Order (ABO) issued as Permit No. 9527, 1974 - Butte Creek Farms) [Additional Reference(s): DWR Levee Log, 2002. USACE Sacramento O&M Manual 136, March 1960 (HLM 1.1)]. FS Date: 8/30/2018 12:42:00 PM

Waterside view: CMP riser with slide gate

Waterside view: inside CMP riser

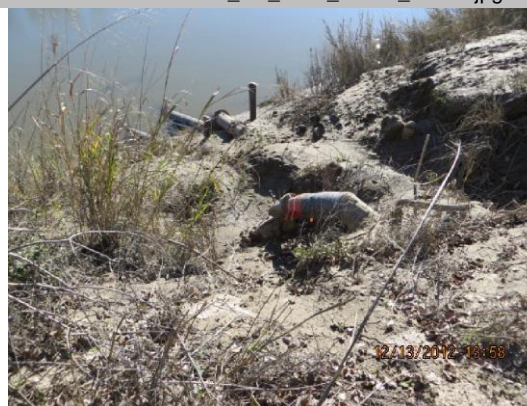
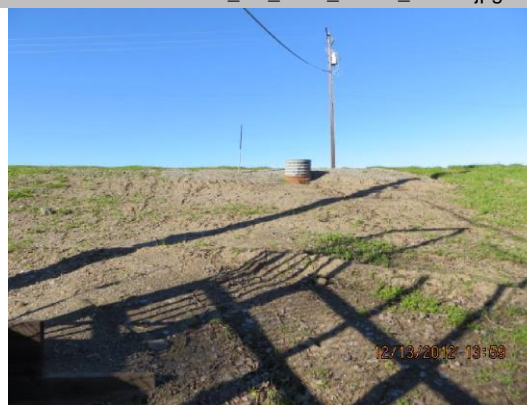
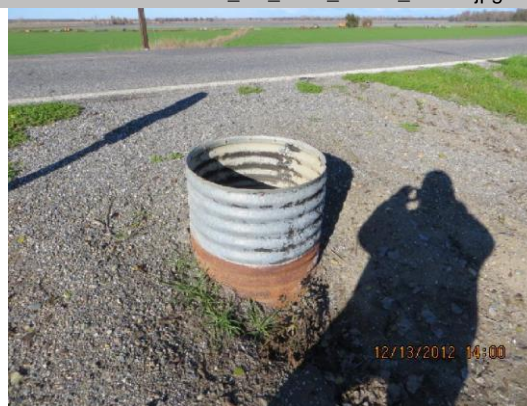
Comment Code						
Inspector Comment						
FS_ID:51656 DS_ID:17322 EP_NO: 9258 Repair Type: Non-Urgent Crossing Status: Found UCIP Comments: 4/24/2017 WS riser was still full of soil. Open 10" pipe on the WS bank was underwater during time of site visit. (DWR Sutter Yard- A Freitag)11/7/2016 WS riser still full of soil. No pump present and 10" pipe left opened on the WS. (DWR Sutter Yard- A Freitag)6/17/2016 Same as last inspection. 4/6/2015 CMP riser filled with silt/soil on WS. No other issues present.6/30/2014 Same as last inspection.12/30/2013 Same as last inspection.7/29/2013 Same as last inspection. FIELD_STRUCT_DESC: 10-inch asphalt coated steel irrigation pipe through the levee, 3.7 feet below the crown. Pump installed on the waterside (WS). (Permit No. 9258, 1974 - Harada). [Additional Reference(s): DWR Levee Log, 2002]. FS Date: 4/26/2017 10:15:33 AM

Waterside view: overview

Waterside view: overview of CMP riser

Waterside view: CMP riser

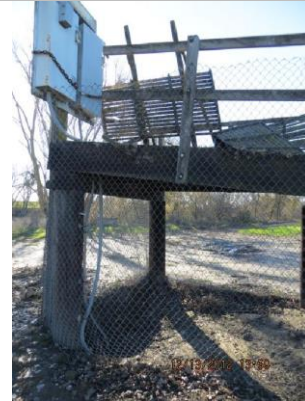
Photo 3 of 3 : UCIP_SP_2019_52947_47002.jpg

FS_ID:52947
DS_ID:17321
EP_NO: 9543
Repair Type: Non-Urgent
Crossing Status: Found
UCIP Comments: 8/30/2018 BRAND-NEW pipe and pump structure installed at this location. Pump in operation at time of inspection and no leaks were visible. Downgraded to Non-Urgent; will be further downgraded to No Action Needed when paperwork compliance with CVFPB is confirmed (D. Sanoski - DWR UCIP).4/24/2017
Abandoned and needs to be done so properly. Vegetation was to thick on the LS slope to see and sloughing or slope damage. (DWR Sutter Yard- AFreitag)11/7/2016 Abandoned. (DWR Sutter Yard- AFreitag)6/17/2016 Abandoned crossing. (DWR Sutter Yard - afreitag)4/5/2016 Appears abandoned and should be done so properly. LS levee slope has a slight but sudden drop (could be due to improper compaction). Dense vegetation on LS prevented visibility of sloughing or other damage to levee. Could not locate leaky pipe marker. Per Bryan Reniff of Sutter Yard, marker was previously installed due to a high water event, not leaky pipe. Appears repair work to levee performed but unclear of extent. Gate valve on WS is bent and damaged, appears abandoned. Crossing a good candidate for video inspection. (DWR UCIP - kfazel)4/6/2015 Sloughing LS slope and river bank. DWR marking for leaky pipe. (DWR Sutter Yard - afreitag)6/30/2014 Same as last inspection. (DWR Sutter Yard - afreitag)12/30/2013 Same as last inspection. (DWR Sutter Yard - afreitag)7/29/2013 Same as last inspection. (DWR Sutter Yard - afreitag)12/13/2012 Sloughing LS slope and river bank. DWR marking for leaky pipe. (DWR UCIP - pamatya)

Waterside view: abandoned pump station close-up.

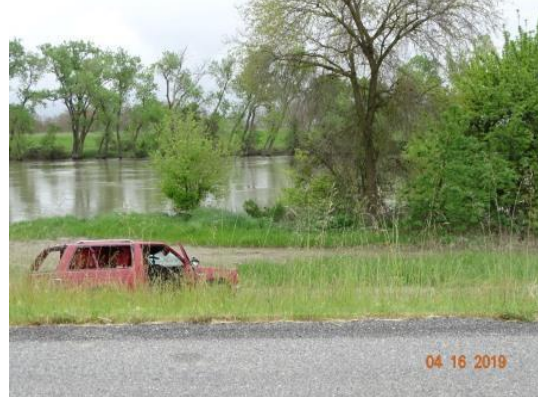
Photo 1 of 1 : SP_2019_ST0003_264_88_20190418_00187.jpg

LM Start	1.93	Rating **	M	Issue No.	88
LM End	1.93	Issue Type +	Ma	Location *	WS
Category	Earthen Levee			GPS Latitude/Longitude	
				Start	End
Item	Encroachments			39.188102 °	39.188102 °
				-121.964988 °	-121.964988 °
DWR ID	DWR_ST0003_01_s_2019_88				
Comment Code					
AV : Abandoned vehicles					
Inspector Comment					
The abandoned vehicle should be removed from the waterside slope.

View of the abandoned vehicle on the waterside slope. Spring 2019.

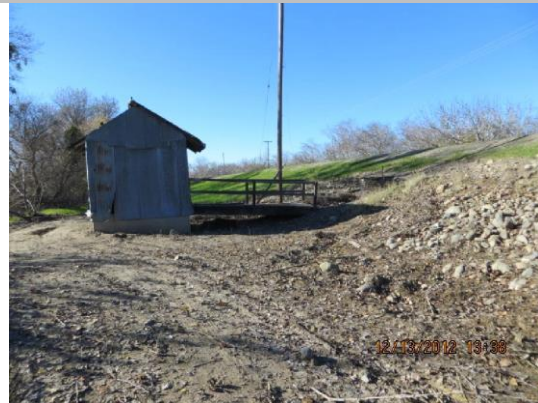
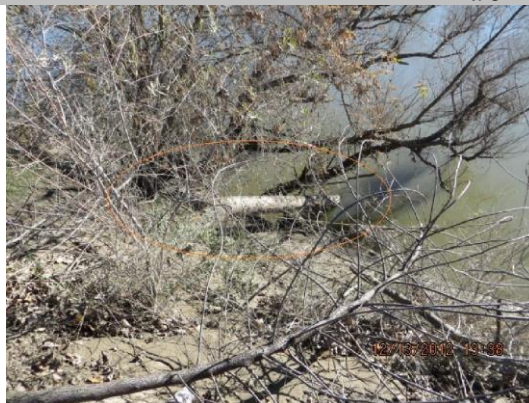
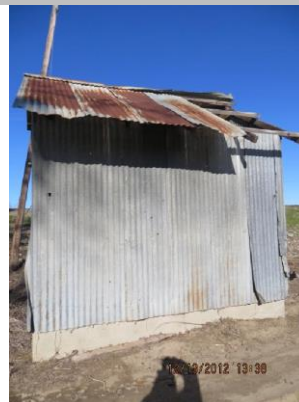
Comment Code					
Inspector Comment					
FS_ID:51658 DS_ID:17305 EP_NO: 9541 Repair Type: Non-Urgent Crossing Status: Found UCIP Comments: 4/24/2017 Abandoned and needs to be done so properly. (DWR Sutter Yard- AFreitag)11/7/2016 Abandoned. (DWR Sutter Yard- AFreitag)6/6/2016 Abandoned crossing. Should be properly abandoned.4/6/2015 Same as last inspection. CMP standpipe with gate valve. Abandoned pump house. Pipe discharges into open ditch at landward toe- not found.6/30/2014 Same as last inspection.12/30/2013 Same as last inspection.7/29/2013 Same as last inspection. FIELD_STRUCT_DESC: *ABANDONED* 24-inch irrigation pipe of an unknown material through the levee, 13.5 feet below the crown. Pump in a metal house on the WS (waterside) berm. Slide gate in a corrugated metal pipe riser on the WS slope. Service pole and guy wire anchor on the WS slope. (Automatic Board Order (ABO) issued as Permit No. 9541, 1974 - Wilbur, McGowan, Zinke). [Additional Reference(s): DWR Levee Logs, 2002. USACE Sacramento O&M Manual 136, March 1960 (HLM 2.01)]. FS Date: 4/26/2017 10:40:26 AM

Waterside view: overview

Waterside view: overview of pipe

Waterside view: abandoned pump house

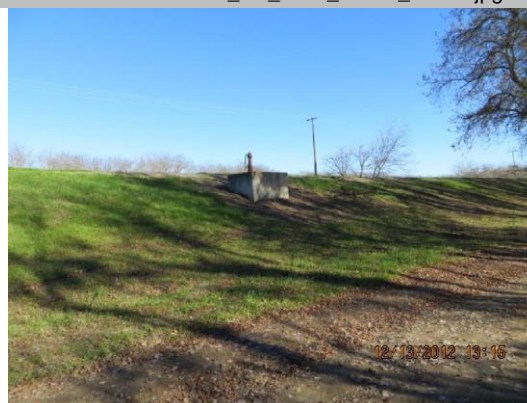
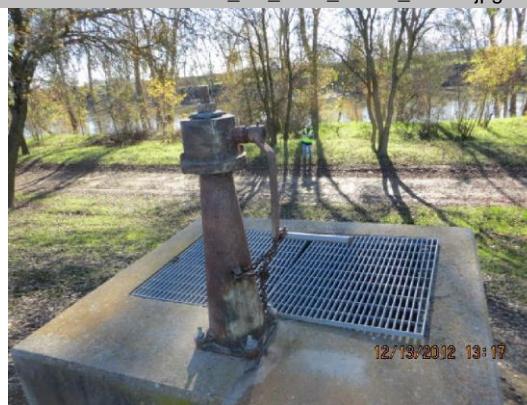
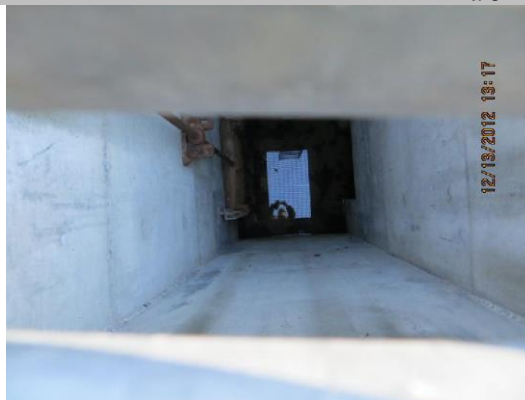
Comment Code						
Inspector Comment						
FS_ID:51660 DS_ID:17309 EP_NO: 9541 Repair Type: Non-Urgent Crossing Status: Found UCIP Comments: 4/24/2017 Still no sign of WS pipe end or flapgate. LS appears to be in good condition. (DWR Sutter Yard- AFreitag) 11/7/2016 LS culvert measured to be 30"wide X 30"tall. WS end is not visible so could not be measured. (DWR Sutter Yard- AFreitag)6/6/2016 Cannot locate the WS headwall/flapgate. Appears to have been silted over.4/6/2015 Same as last inspection. Concrete surg box on WS. Flap gate in concrete "U" headwall at the waterward end- not found.6/30/2014 Same as last inspection.12/30/2013 Same as last inspection.7/29/2013 Same as last inspection. FIELD_STRUCT_DESC: 30-inch reinforced concrete box drainage culvert through the levee, 14.3 feet below the crown. 30-inch corrugated metal pipe connects concrete culvert from slide gate out to flap gate on the waterside (WS) end. Slide gate in a concrete riser on the waterside (WS) slope. (30-inch pipe [HLM 2.49] authorized under Automatic Board Order (ABO) issued as Permit No. 9541, 1974 - Wilbur, McGowan, Zinke). [Additional Reference(s): DWR Levee Logs, 2002. USACE Sacramento O&M Manual 136, March 1960 (HLM 2.49)]. FS Date: 4/26/2017 10:46:22 AM

Waterside view: overview- concrete surg tank

Waterside view: slide gate inside concrete surg tank

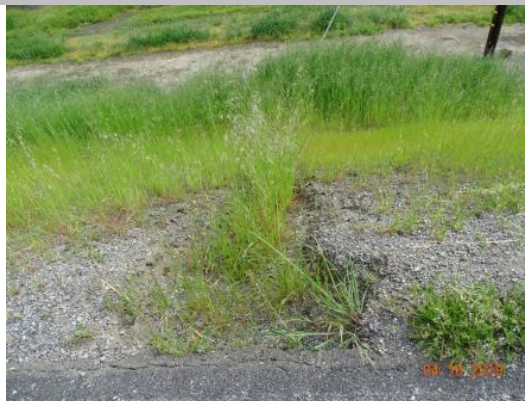
Photo 1 of 1 : SP_2019_ST0003_264_103_20190418_00188.jpg

LM Start	2.79	Rating **	M	Issue No.	103
LM End	2.79	Issue Type +	Ma	Location *	LS
Category	Earthen Levee			GPS Latitude/Longitude	
				Start	End
Item	Erosion / Bank Caving			39.190671 °	39.190671 °
				-121.979706 °	-121.979706 °
DWR ID	DWR_ST0003_01_s_2019_103				
Comment Code					
E2 : Schedule repair of erosion site prior to the next inspection.					
Inspector Comment

View of the erosion on the landside slope. Spring 2019.

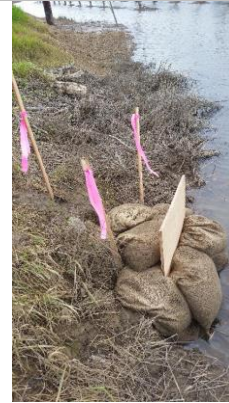
Photo 3 of 3 : UCIP_SP_2019_52949_76921.jpg

Comment Code						
Inspector Comment						
FS_ID:52949 DS_ID:17311 EP_NO: N/A Repair Type: Urgent Crossing Status: Found UCIP Comments: 8/30/2018 Pipe found; at a different Lat/Long than is listed, however. Revised Lat/Long is (39.196865, -121.985280; CLM 3.32). WS pipe end is visible and has a functioning slide gate; LS pipe end is exposed with no closure device or headwall. Keeping as Urgent because the LS pipe discharges into a hole and could pose a threat to the levee prism during a high water event. There are also cracks on the crown that could be related to the pipe beneath. Recommend an internal pipe inspection to be sure of the levee integrity (D.Sanoski - DWR UCIP).4/6/2017 Pipe was found in January 2017 during a high water event when water uncovered the buried WS end which led to uncontrolled water flow through during the high water event. The WS pipe opening was temporarily blocked off by plywood and sandbags until the pipe can be properly plugged or abandoned. Pics updated. (DWR Sutter Yard- Afreitag)11/7/2016 Unable to locate. (DWR Sutter Yard- AFreitag)6/6/2016 Unable to locate.4/6/2015 Unable to locate.6/30/2014 Unable to locate.12/30/2013 Unable to locate.7/29/2013 Same as last inspection. Unable to locate. FIELD_STRUCT_DESC: 24-inch corrugated metal drainage pipe through the levee, 12.4 feet below the crown. Slide gate on the waterside (WS) end. (Automatic Board Order (ABO) issued as Permit No. 9539, 1974 - Locvich). [Additional Reference(s): DWR Levee Log, 2002. USACE Sacramento O&M Manual 136, March 1960 (HLM 3.25)]. FS Date: 8/30/2018 1:45:35 PM

WS view of the temporary plug on WS end.

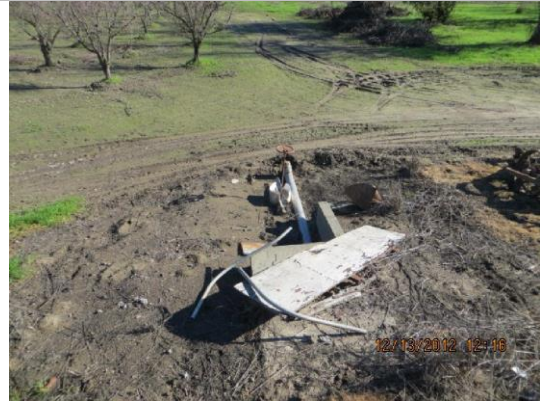
Photo 2 of 3 : UCIP_SP_2019_53401_47046.jpg

Comment Code					
Inspector Comment					
FS_ID:53401 DS_ID:17312 EP_NO: 9539 Repair Type: Urgent Crossing Status: Found UCIP Comments: 8/30/2018 Same as last inspection. Recommend internal pipe inspection to verify pipe integrity and levee integrity so crossing remains Urgent (D. Sanoski - DWR UCIP).4/24/2017 Pipe leaked during the Jan/Feb 2017 high water event. Gap between the top of the WS headwall and concrete plug plus the WS airvents going underwater are the cause of the uncontrolled water flows. (DWR Sutter Yard- AFreitag)11/7/2016 Nothing has changed with this crossing since the last inspection. The gap between the top of the WS headwall and concrete plug could be a problem with water flow during high water times. (DWR Sutter Yard- AFreitag)6/6/2016 One of the pipes appear to be leaking inside of the concrete culvert. From the WS headwall water can be heard flowing inside of the levee behind the concrete plug. The concrete plug also appears to leak as water current can be seen flowing around it. There is also a 1" gap at the top of the plug and the old WS headwall that will allow high water to flow through uncontrolled. (DWR Sutter Yard - afreitag)4/6/2015 6-inch and 18-inch pipes still present in crossing and WS end still plugged with concrete. It seems that the system was originally designed for drainage but later converted into an irrigation system. 6-inch GI pipe and 18-inch PVC pipes inserted into culvert from LS (not plugged). WS opening is plugged with concrete. Probably pump is located 350 ft from levee as seen from Google Earth Map. (DWR Sutter Yard - afreitag)6/30/2014 Same as last inspection. (DWR Sutter Yard - afreitag)12/30/2013 Same as last inspection. (DWR Sutter Yard - afreitag)7/29/2013 Same as last inspection. (DWR Sutter Yard - afreitag) FIELD_STRUCT_DESC: 30-inch by 36-inch reinforced concrete box drainage and irrigation culvert through the levee, invert 13.6 feet below the crown. Gates with 2-inch flashboards on the waterside (WS) end. 6-inch and 18-inch polyvinyl chloride (PVC) pipes through the culvert on the landside (LS). Culvert designed for drainage but now used for irrigation. (Automatic Board Order (ABO) issued as Permit No. 9539, 1974 - Locvich). [Additional Reference(s): DWR Levee Log, 2002. USACE Sacramento O&M Manual 136, March 1960 (HLM 3.33)]. FS Date: 8/30/2018 10:18:00 AM

Landside view: overview- concrete culvert and pipes

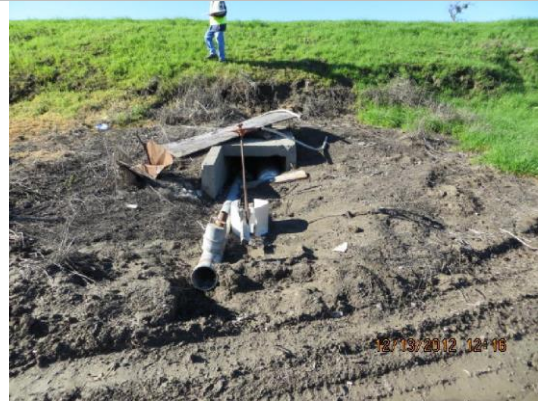
Photo 3 of 3 : UCIP_SP_2019_53401_47047.jpg

FS_ID:53401
DS_ID:17312
EP_NO: 9539
Repair Type: Urgent
Crossing Status: Found
UCIP Comments: 8/30/2018 Same as last inspection. Recommend internal pipe inspection to verify pipe integrity and levee integrity so crossing remains Urgent (D. Sanoski - DWR UCIP).4/24/2017 Pipe leaked during the Jan/Feb 2017 high water event. Gap between the top of the WS headwall and concrete plug plus the WS airvents going underwater are the cause of the uncontrolled water flows. (DWR Sutter Yard- AFreitag)11/7/2016 Nothing has changed with this crossing since the last inspection. The gap between the top of the WS headwall and concrete plug could be a problem with water flow during high water times. (DWR Sutter Yard- AFreitag)6/6/2016 One of the pipes appear to be leaking inside of the concrete culvert. From the WS headwall water can be heard flowing inside of the levee behind the concrete plug. The concrete plug also appears to leak as water current can be seen flowing around it. There is also a 1" gap at the top of the plug and the old WS headwall that will allow high water to flow through uncontrolled. (DWR Sutter Yard - afreitag)4/6/2015 6-inch and 18-inch pipes still present in crossing and WS end still plugged with concrete. It seems that the system was originally designed for drainage but later converted into an irrigation system. 6-inch GI pipe and 18-inch PVC pipes inserted into culvert from LS (not plugged). WS opening is plugged with concrete. Probably pump is located 350 ft from levee as seen from Google Earth Map. (DWR Sutter Yard - afreitag)6/30/2014 Same as last inspection. (DWR Sutter Yard - afreitag)12/30/2013 Same as last inspection. (DWR Sutter Yard - afreitag)7/29/2013 Same as last inspection. (DWR Sutter Yard - afreitag)

Landside view: overview of concrete culvert and pipes

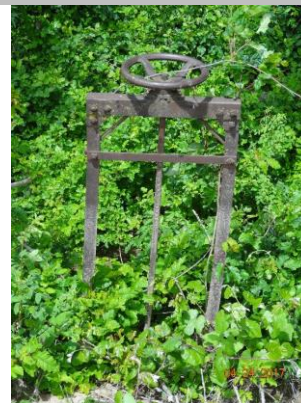
Photo 1 of 2 : UCIP_SP_2019_51666_77004.jpg

Slide gate structure found on WS

FS_ID:51666
DS_ID:17313
EP_NO: N/A
Repair Type: Non-Urgent
Crossing Status: Found
UCIP Comments: 4/24/2017 Slide gate structure found on WS about 10ft from levee toe. Vegetation was too thick to see if there were any more appurtances associated with this crossing visible on the WS. Nothing was visible on the LS. House located above pipe alignment at LS levee toe. Crossing appears abandoned and should be done so properly. (DWR Sutter Yard- AFreitag)11/7/2016 Unable to locate. (DWR Sutter Yard- AFreitag)6/6/2016 Unable to locate.4/6/2015 Unable to locate.6/30/2014 Unable to locate.12/30/2013 Unable to locate7/29/2013 Same as last inspection. Unable to locate.
FIELD_STRUCT_DESC: *ABANDONED* 18-inch corrugated metal drainage pipe through the levee, 15 feet below the crown. Slide gate on the waterside (WS) end. [Additional Reference(s): DWR Levee Log, 2002. USACE Sacramento O&M Manual 136, March 1960 (HLM 3.6)].

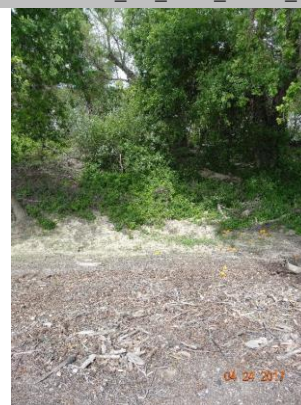
Photo 2 of 2 : UCIP_SP_2019_51666_77005.jpg

View of WS from levee shoulder

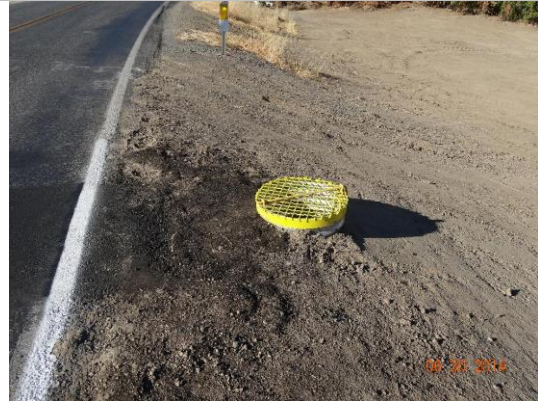
Photo 2 of 3 : UCIP_SP_2019_51671_71479.jpg

FS_ID:51671
DS_ID:17314
EP_NO: 9501-1
Repair Type: Non-Urgent
Crossing Status: Found
UCIP Comments: 4/24/2017 Crossing appears to be in good condition. (DWR Sutter Yard- AFreitag)11/7/2016 Crossing appears to be in good condition. (DWR Sutter Yard- AFreitag)6/17/2016 DO NOT BELIEVE THIS IS AN ABANDONED CROSSING- there is a newer looking pump present inside the WS pump house with an active PG&E power meter. Also the dirt below the siphon breaker inside of the riser on the LS shoulder was wet indicating that the breaker has had running water through it recently. Also the ground under the LS toe airvent was wet indicating that it too has recently had water flowing through it.

4/4/2016 Concrete box on LS still silted in. Cracking and slope failure previously cited appears to have been repaired as we could not locate. Shutoff valves appear in good condition. If crossing is abandoned, should be done so properly. 4/6/2015 Same as last inspection. Concrete pit on WS berm. Concrete distribution box on LS silted and erosion around the box. Slope failure/ transverse cracks on LS levee slope. Two depressions on WS berm. 6/30/2014 Crossing appears to be being made active again. WS bank has been cleared of all vegetation and debris to allow pump to slide down to water level. New shutoff valve installed on WS shoulder inside of cmp stand pipe. New air-vac installed inside cmp standpipe on LS shoulder and air vent installed on LS toe. Could not locate pipe end on LS. Need to check for permit number for work done. 12/30/2013 Repairs to LS and WS slopes have been completed. Not sure if this is an active or abandoned crossing. LS distribution box is still silted in. 7/29/2013 Repairs to LS slope and pipe are in progress. Nothing has been done yet to the WS depressions.

WS standpipe with shut off valve inside

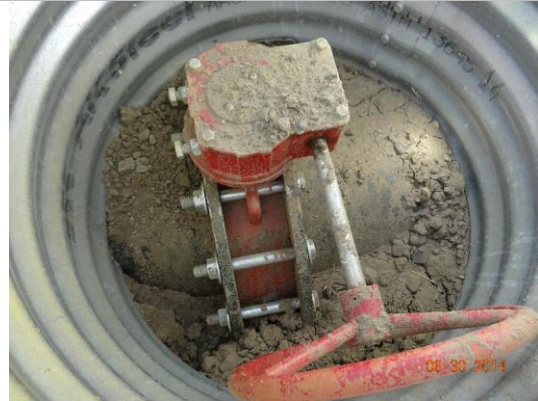
Photo 3 of 3 : UCIP_SP_2019_51671_71478.jpg

FS_ID:51671
DS_ID:17314
EP_NO: 9501-1
Repair Type: Non-Urgent
Crossing Status: Found
UCIP Comments: 4/24/2017 Crossing appears to be in good condition. (DWR Sutter Yard- AFreitag)11/7/2016 Crossing appears to be in good condition. (DWR Sutter Yard- AFreitag)6/17/2016 DO NOT BELIEVE THIS IS AN ABANDONED CROSSING- there is a newer looking pump present inside the WS pump house with an active PG&E power meter. Also the dirt below the siphon breaker inside of the riser on the LS shoulder was wet indicating that the breaker has had running water through it recently. Also the ground under the LS toe airvent was wet indicating that it too has recently had water flowing through it.

4/4/2016 Concrete box on LS still silted in. Cracking and slope failure previously cited appears to have been repaired as we could not locate. Shutoff valves appear in good condition. If crossing is abandoned, should be done so properly. 4/6/2015 Same as last inspection. Concrete pit on WS berm. Concrete distribution box on LS silted and erosion around the box. Slope failure/ transverse cracks on LS levee slope. Two depressions on WS berm. 6/30/2014 Crossing appears to be being made active again. WS bank has been cleared of all vegetation and debris to allow pump to slide down to water level. New shutoff valve installed on WS shoulder inside of cmp stand pipe. New air-vac installed inside cmp standpipe on LS shoulder and air vent installed on LS toe. Could not locate pipe end on LS. Need to check for permit number for work done. 12/30/2013 Repairs to LS and WS slopes have been completed. Not sure if this is an active or abandoned crossing. LS distribution box is still silted in. 7/29/2013 Repairs to LS slope and pipe are in progress. Nothing has been done yet to the WS depressions.

WS shut off valve

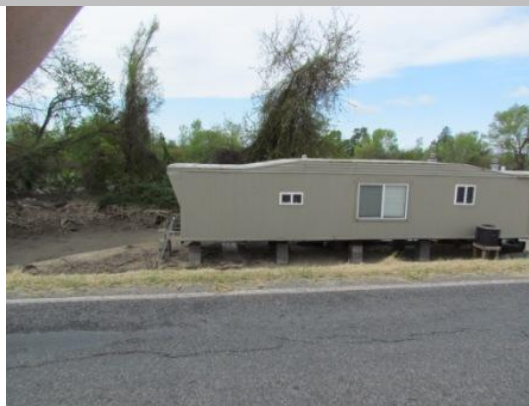
Photo 1 of 1 : SP_2019_ST0003_264_11_20190327_00008.jpg

LM Start	4.26	Rating **	M	Issue No.	11							
LM End	4.26	Issue Type +	En	Location *	WS							
Category	Earthen Levee		GPS Latitude/Longitude									
			Start	End								
Item	Encroachments		39.208971 °	39.208971 °								
			-121.985374 °	-121.985374 °								
DWR ID	DWR_ST0003_01_f_2016_11											
Comment Code												
BU : Building												
Inspector Comment

View of a trailer next to the waterside toe.

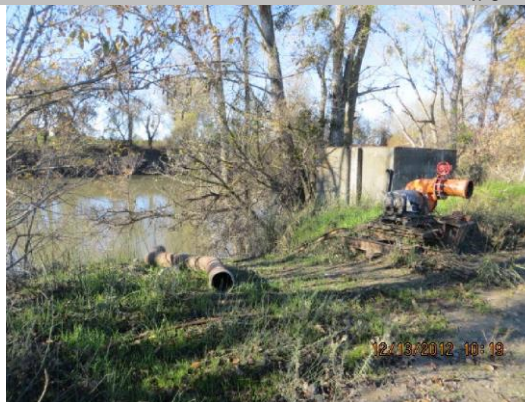
Photo 2 of 3 : UCIP_SP_2019_52952_47067.jpg

FS_ID:52952
DS_ID:17297
EP_NO: 9501-A
Repair Type: Non-Urgent
Crossing Status: Found
UCIP Comments: 8/30/2018 Same as last inspection, with no signs of any improvements made to pipe or pump. Vegetation obstructed full inspection at water level, but the levee looks in very good condition with no signs of threat. Downgrading to Non-Urgent from Urgent due to the good condition of the levee (D. Sanoski - DWR UCIP).4/24/2017 WS was mostly underwater during site visit. Not sure if the 10" pipe was still opened or capped on the WS end but no water appeared to be free flowing through the levee. No sign of orange pump. (DWR Sutter Yard-AFreitag)11/7/2016 Orange pump was not present at this inspection. 10" pipe penetration left opened on WS end. (DWR Sutter Yard-AFreitag)6/17/2016 Orange pump motor was lowered down the WS berm to water level and was pumping water through the pipe to the LS outlet. What is pictured in (photo#17 UCIP_Photos_No.75150) as "pipe debris" is the pipe section that is used to connect the orange pump to the open 10" pipe that penetrates the levee. In the same photo the "possible penetration" is the flexible suction line for the pump. (DWR Sutter Yard - aFreitag)4/4/2016 Flow meter installed on LS indicates this pipe is used seasonally and not abandoned. Pipe open on WS (see photo). No cover on old siphon breaker. Slight sloughing of LS slope. (DWR UCIP - kfazel)4/6/2015 Pump disconnected and pulled up to WS toe. Not Sure if leaky valve has ever been fixed. (DWR Sutter Yard - aFreitag)6/30/2014 Same as last inspection. (DWR Sutter Yard - aFreitag)12/30/2013 Same as last inspection. (DWR Sutter Yard - aFreitag)7/29/2013 Not an abandoned crossing. Pump is connected to WS pipe end at water level and is pumping water to LS and then goes underground to an irrigation ditch about 100yds. upstream. Pump and pipes are disconnected and pulled up to WS toe for high water season. Leaky valve on LS shoulder does not appear to have been fixed. (DWR Sutter Yard - aFreitag)12/12/2012 Motor and pump on berm. Appears an abandoned crossing. Leaky valve on LS slope. Pipe removed and laying on berm. No electric connection to the pump. (DWR UCIP - pamatya)

Waterside view: overview of pump and abandoned pipe

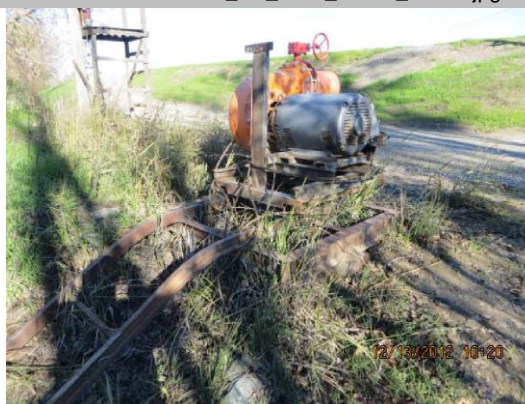
Photo 3 of 3 : UCIP_SP_2019_52952_47066.jpg

WS view: pump motor on the berm (found at water level in 2016)

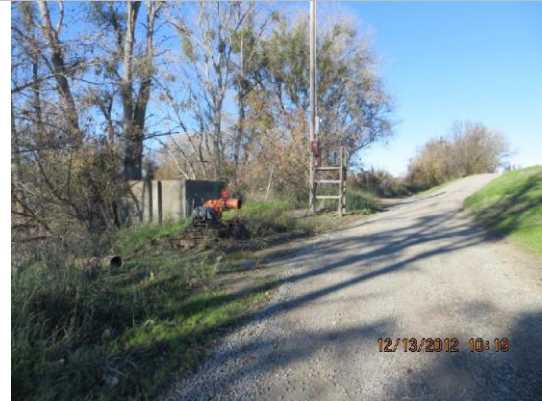
Photo 2 of 3 : UCIP_SP_2019_52953_47079.jpg

FS_ID:52953
 DS_ID:17326
 EP_NO: 9501
 Repair Type: Non-Urgent
 Crossing Status: Found
 UCIP Comments: 8/30/2018 Same as last inspection. Needs to be abandoned properly; downgrading to Non-Urgent from Urgent (D. Sanoski - DWR UCIP). 4/24/2017 Abandoned and needs to be done properly. (DWR Sutter Yard- A Freitag) 11/7/2016 Abandoned and should be done so properly. (DWR Sutter Yard- A Freitag) 6/17/2016 Abandoned pipe. photo comments updated. (DWR Sutter Yard - a Freitag) 4/4/2016 Open on WS. Needs proper abandonment. Contact owner to determine status of crossing. (DWR UCIP - kfazel) 4/6/2015 Same as last inspection. (DWR Sutter Yard - a Freitag) 6/30/2014 Same as last inspection. (DWR Sutter Yard - a Freitag) 12/30/2013 Same as last inspection. (DWR Sutter Yard - a Freitag) 7/29/2013 Same as last inspection. (DWR Sutter Yard - a Freitag) 12/12/2012 Need to be properly abandoned. Transverse cracks on levee road. Also found a concrete outlet on LS. It is not clear whether this passes through the levee. (DWR UCIP - pamatya)

Waterside view: overview

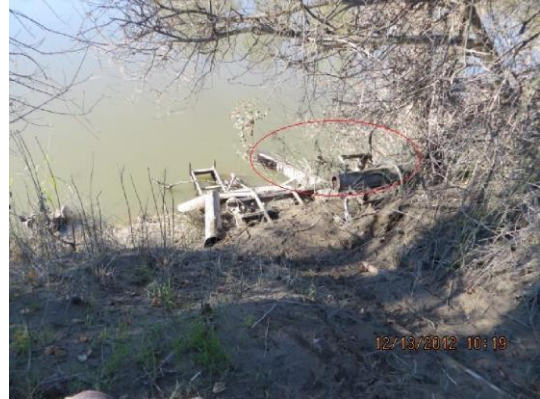
Photo 3 of 3 : UCIP_SP_2019_52953_47078.jpg

FS_ID:52953
DS_ID:17326
EP_NO: 9501
Repair Type: Non-Urgent
Crossing Status: Found
UCIP Comments: 8/30/2018 Same as last inspection. Needs to be abandoned properly; downgrading to Non-Urgent from Urgent (D. Sanoski - DWR UCIP). 4/24/2017 Abandoned and needs to be done properly. (DWR Sutter Yard- A Freitag) 11/7/2016 Abandoned and should be done so properly. (DWR Sutter Yard- A Freitag) 6/17/2016 Abandoned pipe. photo comments updated. (DWR Sutter Yard - a Freitag) 4/4/2016 Open on WS. Needs proper abandonment. Contact owner to determine status of crossing. (DWR UCIP - kfazel) 4/6/2015 Same as last inspection. (DWR Sutter Yard - a Freitag) 6/30/2014 Same as last inspection. (DWR Sutter Yard - a Freitag) 12/30/2013 Same as last inspection. (DWR Sutter Yard - a Freitag) 7/29/2013 Same as last inspection. (DWR Sutter Yard - a Freitag) 12/12/2012 Need to be properly abandoned. Transverse cracks on levee road. Also found a concrete outlet on LS. It is not clear whether this passes through the levee. (DWR UCIP - pamatya)

Waterside view: overview of pipe

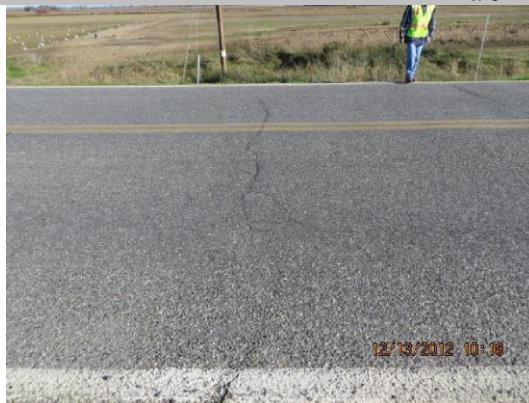
Photo 1 of 3 : UCIP_SP_2019_51676_47087.jpg

FS_ID:51676
DS_ID:17484
EP_NO: N/A
Repair Type: Non-Urgent
Crossing Status: Found
UCIP Comments: 4/24/2017 Abandoned- needs to be done so properly. WS underwater during site visit. (DWR Sutter Yard- A Freitag) 11/7/2016 Abandoned but needs to be done so properly. (DWR Sutter Yard- A Freitag) 9/29/2016 Crossing has been downgraded from Urgent to Non-Urgent crossing is abandoned and WS surge box is full of debris. Need to contact owner and have owner coordinate with CVFPB to comply with Title 23. (DWR UCIP - omagana) 6/17/2016 Abandoned crossing. Photo comments updated. (DWR Sutter Yard - a Freitag) 4/4/2016 Same as last inspection. (DWR UCIP - kfazel) 4/6/2015 Crossing appears to be an old irrigation structure and not a drain pipe. It appears abandoned as WS surge box is full of debris. (DWR Sutter Yard - a Freitag) 6/30/2014 Same as last inspection. (DWR Sutter Yard - a Freitag) 12/30/2013 Same as last inspection. (DWR Sutter Yard - a Freitag) 7/29/2013 Same as last inspection. (DWR Sutter Yard - a Freitag) 12/12/2012 Debris and deteriorated concrete. Gate valve in surge tank. (DWR UCIP - pamatya) FIELD_STRUCT_DESC: *ABANDONED* 24-inch steel irrigation pipe through the levee, invert 26 feet below the crown. Slide gate on the waterside (WS). [Additional Reference(s): USACE Sacramento O&M Manual 136, March 1960 (HLM 4.37)].

Crown view: transverse crack on levee road

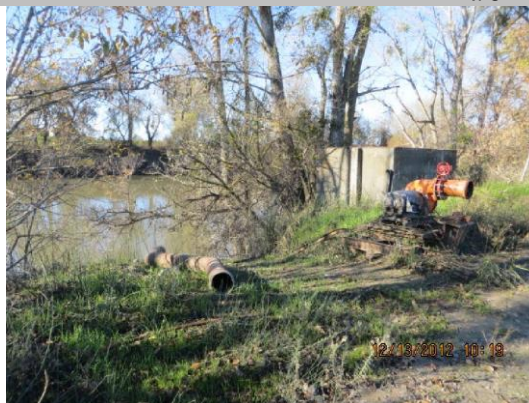
Photo 2 of 3 : UCIP_SP_2019_51676_47086.jpg

Waterside view: overview of concrete surge box

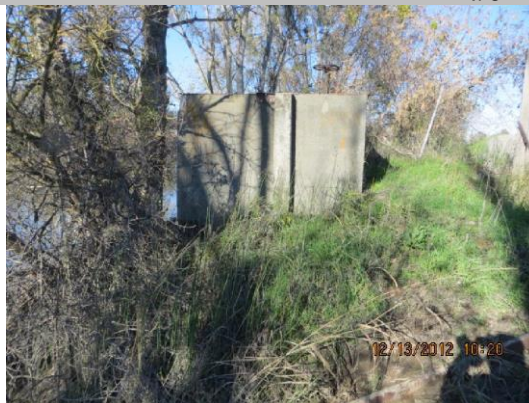
Photo 3 of 3 : UCIP_SP_2019_51676_47085.jpg

Comment Code						
Inspector Comment						
FS_ID:51676 DS_ID:17484 EP_NO: N/A Repair Type: Non-Urgent Crossing Status: Found UCIP Comments: 4/24/2017 Abandoned- needs to be done so properly. WS underwater during site visit. (DWR Sutter Yard- A Freitag)11/7/2016 Abandoned but needs to be done so properly. (DWR Sutter Yard- A Freitag)9/29/2016 Crossing has been downgraded from Urgent to Non-Urgent crossing is abandoned and WS surge box is full of debris. Need to contact owner and have owner coordinate with CVFPB to comply with Title 23. (DWR UCIP - omagana)6/17/2016 Abandoned crossing. Photo comments updated. (DWR Sutter Yard - a Freitag)4/4/2016 Same as last inspection. (DWR UCIP - kfazel)4/6/2015 Crossing appears to be an old irrigation structure and not a drain pipe. It appears abandoned as WS surge box is full of debris. (DWR Sutter Yard - a Freitag)6/30/2014 Same as last inspection. (DWR Sutter Yard - a Freitag)12/30/2013 Same as last inspection. (DWR Sutter Yard - a Freitag)7/29/2013 Same as last inspection. (DWR Sutter Yard - a Freitag)12/12/2012 Debris and deteriorated concrete. Gate valve in surge tank. (DWR UCIP - pamatya) FIELD_STRUCT_DESC: *ABANDONED* 24-inch steel irrigation pipe through the levee, invert 26 feet below the crown. Slide gate on the waterside (WS). [Additional Reference(s): USACE Sacramento O&M Manual 136, March 1960 (HLM 4.37)]. FS Date: 4/26/2017 12:59:53 PM

Waterside view: concrete surge box

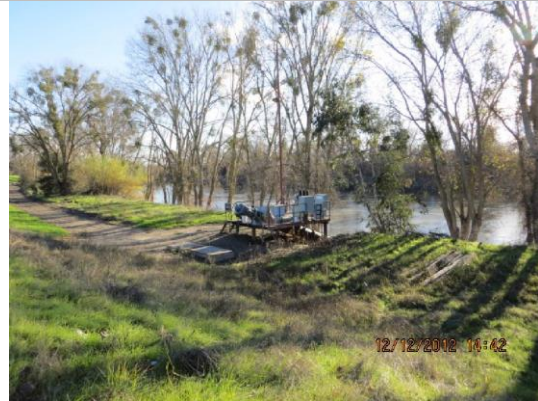
Photo 1 of 3 : UCIP_SP_2019_51677_47092.jpg

FS_ID:51677
DS_ID:17318
EP_NO: 9501
Repair Type: Non-Urgent
Crossing Status: Found
UCIP Comments: 4/24/2017 LS shoulder erosion repaired. Not sure if any changes or repairs were done to the pipe itself. (DWR Sutter Yard- AFreitag)11/7/2016 LS erosion still a problem at the LS shoulder. (DWR Sutter Yard- AFreitag)6/6/2016 LS erosion still present and appears to be getting worse. It is only a few inches away from affecting the paved road way. (DWR Sutter Yard - afreitag)4/4/2016 Same as last inspection. Erosion problem is urgently in need of repair. (DWR UCIP - kfazel)4/6/2015 Erosion problem still present near the LS shoulder. If it gets any worse then it may start to affect the road way. Found a siphon breaker on LS. Antenna and pump station on WS. Huge erosion on LS slope. (DWR Sutter Yard - afreitag)6/30/2014 Same as last inspection. (DWR Sutter Yard - afreitag)12/30/2013 Same as last inspection. (DWR Sutter Yard - afreitag)7/29/2013 Erosion near LS shoulder may start affecting the roadway if it gets any worse.12/12/2012 Found a siphon breaker on LS. Antenna and pump station on WS. Huge erosion on LS slope. (DWR UCIP - pamatya) FIELD_STRUCT_DESC: 24-inch asphalt coated steel irrigation pipe, 4 feet below the crown. Slant pump on a steel platform on the waterside (WS) berm. Siphon breaker on the apex of the pipe and off the levee crown on the landside (LS). 2 shut-off (butterfly) valves off the LS toe. Power pole with electrical conduit and panel on the LS toe. Pipe appears to run diagonally through the levee and discharges into a ditch off the LS toe. Gate structure on the outlet at the ditch. (Automatic Board Order (ABO) issued as Permit No. 9501, 1974 - Mayfair Farms, Inc.). Slant pump installed under Permit No. 10935, 1975 - Pires. [Additional Reference(s): DWR Levee Log, 2002].

Waterside view: overview

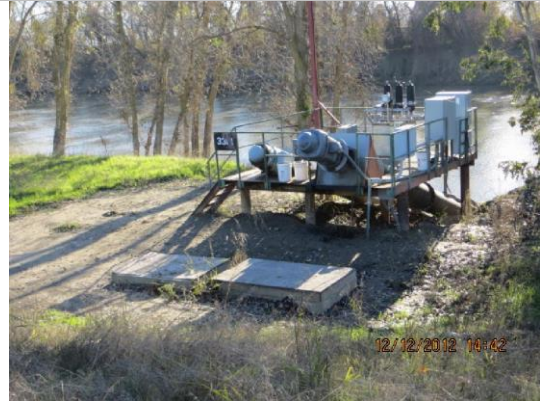
Photo 2 of 3 : UCIP_SP_2019_51677_47091.jpg

Waterside view: overview of pump station

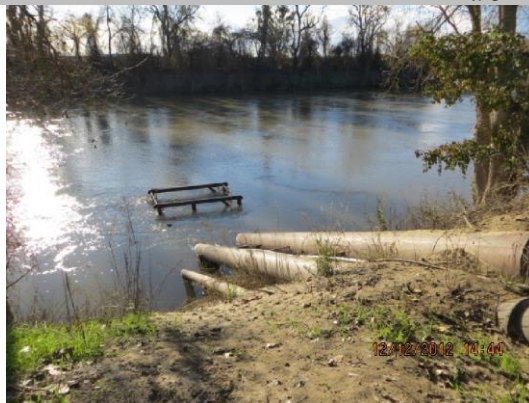
Photo 3 of 3 : UCIP_SP_2019_51677_47096.jpg

Waterside view: inclined pipes

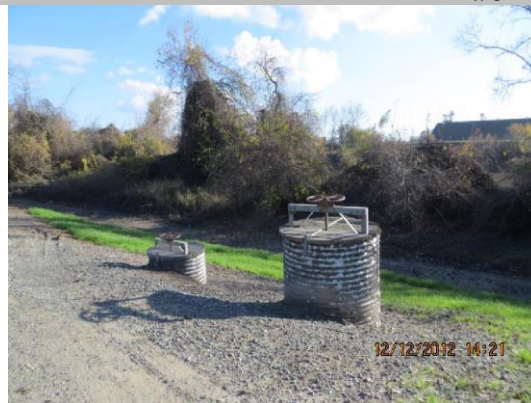
Photo 1 of 3 : UCIP_SP_2019_51680_47112.jpg

Waterside view: CMP riser with slide gate (right)

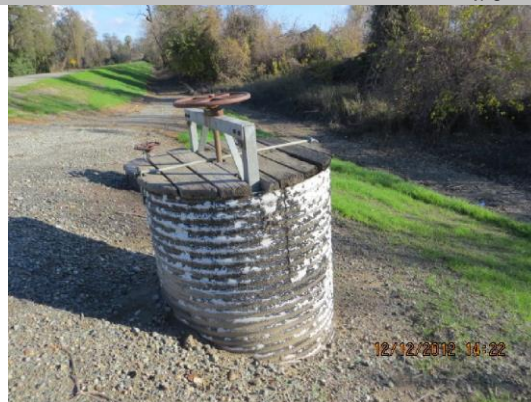
Photo 2 of 3 : UCIP_SP_2019_51680_47111.jpg

Waterside view: CMP riser with slide gate

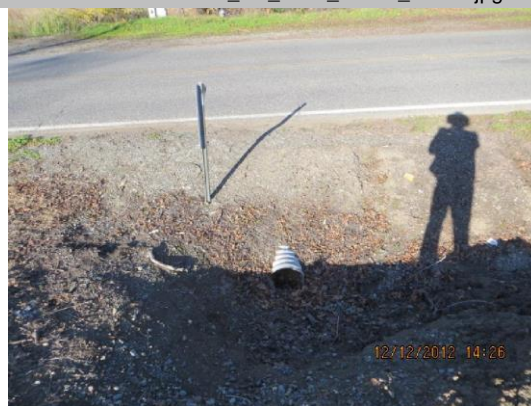
Photo 3 of 3 : UCIP_SP_2019_51680_47110.jpg

Comment Code						
Inspector Comment						
FS_ID:51680 DS_ID:17288 EP_NO: N/A Repair Type: Non-Urgent Crossing Status: Indicator Found UCIP Comments: 4/24/2017 Abandoned- needs to be done so properly. (DWR Sutter Yard- AFreitag)11/7/2016 Appears abandoned, Should be done so properly. (DWR Sutter Yard- AFreitag)6/6/2016 Appears to be an abandoned crossing.4/4/2016 If abandoned, should be done so properly.4/6/2015 Same as last inspection. Only WS riser amd slide gate found.Only a CMP riser with slide gate found on WS.6/30/2014 Same as last inspection.12/30/2013 Same as last inspection.7/29/2013 Same as last inspection. FIELD_STRUCT_DESC: *ABANDONED* 36-inch corrugated metal drainage pipe through the levee, 13.8 feet below the crown, not found in 2015. Slide gate in a CMP riser on the waterside (WS) slope, found in 2015. Flap gate removed at the landside (LS) end. (Automatic Board Order (ABO) issued as Permit No. 9520, 1974 - Arnold). [Additional Reference(s): DWR Levee Log, 2002. USACE Sacramento O&M Manual 136, March 1960 (HLM 4.99)]. FS Date: 4/26/2017 1:19:25 PM

Landside view: overview- county road and road drainpipe

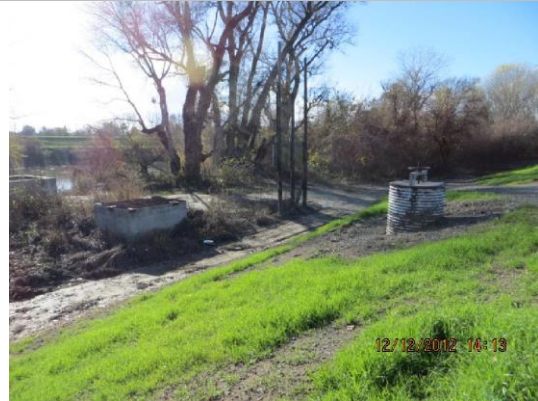
Photo 1 of 3 : UCIP_SP_2019_51681_47115.jpg

FS_ID:51681
DS_ID:17289
EP_NO: N/A
Repair Type: Non-Urgent
Crossing Status: Found
UCIP Comments: 4/24/2017 Appears abandoned- needs to be done so properly. Sloughing still present near WS surge box. (DWR Sutter Yard- A Freitag)11/7/2016 Appears abandoned but needs to be done so properly. (DWR Sutter Yard- A Freitag)6/6/2016 Sink holes appear to have been repaired but there is still some minor sloughing around the WS surge box. Surge box was full of water at time of inspection and I could not see the pipe inside to see if it still looked corroded and rusty.4/4/2016 Could not find sink holes as in 07/2013 photo. Appears repaired, but sloughing still present around surge box. Need confirmation that pipe was abandoned properly.4/6/2015 Repairs are in progress to this crossing. Surge box on WS and distribution box across the county road on LS. Abandoned pump station and electrical panel on WS. A concrete pump pit on WS.6/30/2014 Sink hole near WS surge box is still present. Portable pumps were lowered down the WS bank and were pumping water directly into WS standpipe on to by pass the surge box.12/30/2013 Sink Hole above pipe on WS still present. Pipe end inside of WS surge box shows heavy signs of rust and corrosion. Recommend having an internal camera inspection completed on pipe.7/29/2013 Portable tow-pump lowered down WS berm to water level and is pumping water into concrete surge box on WS and the filling the irrigation ditch on LS. Sink hole with standing water that is present above the outlet pipe for the WS surge box. This may indicate a leaking pipe or cracked concrete.

Waterside view: overview

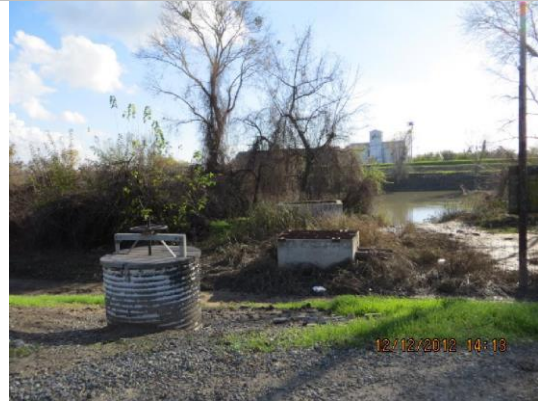
Photo 2 of 3 : UCIP_SP_2019_51681_47113.jpg

FS_ID:51681
DS_ID:17289
EP_NO: N/A
Repair Type: Non-Urgent
Crossing Status: Found
UCIP Comments: 4/24/2017 Appears abandoned- needs to be done so properly. Sloughing still present near WS surge box. (DWR Sutter Yard- A Freitag)11/7/2016 Appears abandoned but needs to be done so properly. (DWR Sutter Yard- A Freitag)6/6/2016 Sink holes appear to have been repaired but there is still some minor sloughing around the WS surge box. Surge box was full of water at time of inspection and I could not see the pipe inside to see if it still looked corroded and rusty.4/4/2016 Could not find sink holes as in 07/2013 photo. Appears repaired, but sloughing still present around surge box. Need confirmation that pipe was abandoned properly.4/6/2015 Repairs are in progress to this crossing. Surge box on WS and distribution box across the county road on LS. Abandoned pump station and electrical panel on WS. A concrete pump pit on WS.6/30/2014 Sink hole near WS surge box is still present. Portable pumps were lowered down the WS bank and were pumping water directly into WS standpipe on to by pass the surge box.12/30/2013 Sink Hole above pipe on WS still present. Pipe end inside of WS surge box shows heavy signs of rust and corrosion. Recommend having an internal camera inspection completed on pipe.7/29/2013 Portable tow-pump lowered down WS berm to water level and is pumping water into concrete surge box on WS and the filling the irrigation ditch on LS. Sink hole with standing water that is present above the outlet pipe for the WS surge box. This may indicate a leaking pipe or cracked concrete.

Waterside view: CMP riser and surge box

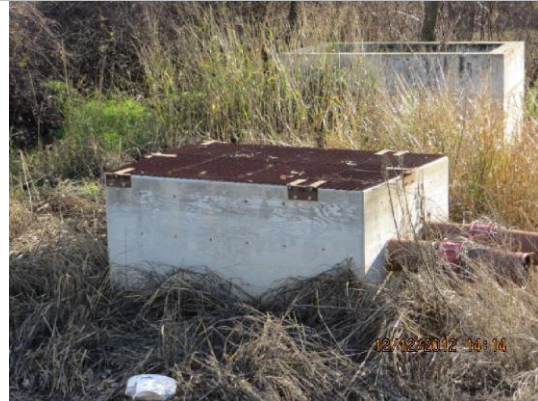
Photo 3 of 3 : UCIP_SP_2019_51681_47114.jpg

FS_ID:51681
DS_ID:17289
EP_NO: N/A
Repair Type: Non-Urgent
Crossing Status: Found
UCIP Comments: 4/24/2017 Appears abandoned- needs to be done so properly. Sloughing still present near WS surge box. (DWR Sutter Yard- A Freitag)11/7/2016 Appears abandoned but needs to be done so properly. (DWR Sutter Yard- A Freitag)6/6/2016 Sink holes appear to have been repaired but there is still some minor sloughing around the WS surge box. Surge box was full of water at time of inspection and I could not see the pipe inside to see if it still looked corroded and rusty.4/4/2016 Could not find sink holes as in 07/2013 photo. Appears repaired, but sloughing still present around surge box. Need confirmation that pipe was abandoned properly.4/6/2015 Repairs are in progress to this crossing. Surge box on WS and distribution box across the county road on LS. Abandoned pump station and electrical panel on WS. A concrete pump pit on WS.6/30/2014 Sink hole near WS surge box is still present. Portable pumps were lowered down the WS bank and were pumping water directly into WS standpipe on to by pass the surge box.12/30/2013 Sink Hole above pipe on WS still present. Pipe end inside of WS surge box shows heavy signs of rust and corrosion. Recommend having an internal camera inspection completed on pipe.7/29/2013 Portable tow-pump lowered down WS berm to water level and is pumping water into concrete surge box on WS and the filling the irrigation ditch on LS. Sink hole with standing water that is present above the outlet pipe for the WS surge box. This may indicate a leaking pipe or cracked concrete.

Waterside view: closer look at surge box

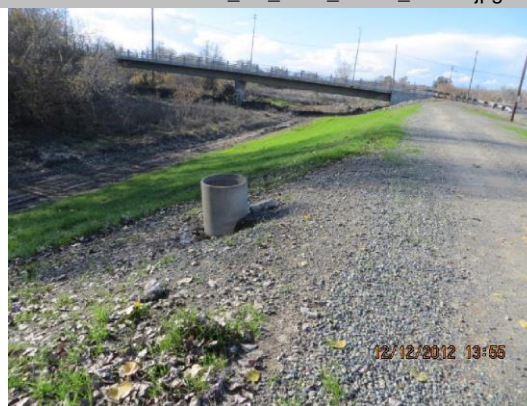
Photo 1 of 3 : UCIP_SP_2019_51683_47127.jpg

Comment Code					
Inspector Comment					
FS_ID:51683 DS_ID:17291 EP_NO: 4091 Repair Type: Non-Urgent Crossing Status: Found UCIP Comments: 4/24/2017 Abandoned- needs to be done properly. (DWR Sutter Yard- A Freitag)11/7/2016 Abandoned and should be done so properly. (DWR Sutter Yard- A Freitag)6/6/2016 Appears to be an abandoned crossing. WS was to over grown with vegetation to access the area where the WS pump structure was previously found.4/6/2015 Same as last inspection. Crossing appears abandoned. Appears abandoned and if so should be done so properly. No Siphon breaker found on LS.6/30/2014 Same as last inspection.12/30/2013 Same as last inspection.7/29/2013 Same as last inspection. FIELD_STRUCT_DESC: *ABANDONED* 8-inch asphalt coated steel irrigation pipe through the levee, 4 feet below the crown. Pump on the waterside (WS) bank. Gate valve in a concrete pipe riser on the WS shoulder. (Permit No. 4091, 1962 - Halsey, Yerxa). [Additional Reference(s): DWR Levee Log, 2002]. FS Date: 4/26/2017 1:30:30 PM

Waterside view: concrete pipe riser with gate valve

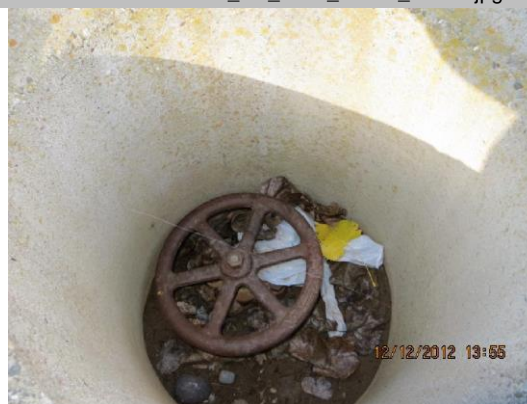
Photo 2 of 3 : UCIP_SP_2019_51683_47126.jpg

Waterside view: buried gate valve in concrete pipe riser

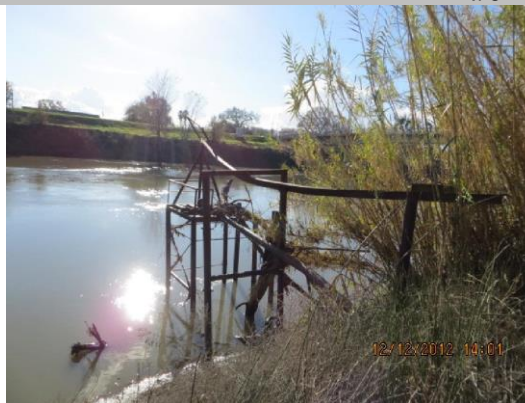
Photo 3 of 3 : UCIP_SP_2019_51683_47129.jpg

Comment Code						
Inspector Comment						
FS_ID:51683 DS_ID:17291 EP_NO: 4091 Repair Type: Non-Urgent Crossing Status: Found UCIP Comments: 4/24/2017 Abandoned- needs to be done properly. (DWR Sutter Yard- AFreitag)11/7/2016 Abandoned and should be done so properly. (DWR Sutter Yard- AFreitag)6/6/2016 Appears to be an abandoned crossing. WS was to over grown with vegetation to access the area where the WS pump structure was previously found.4/6/2015 Same as last inspection. Crossing appears abandoned. Appears abandoned and if so should be done so properly. No Siphon breaker found on LS.6/30/2014 Same as last inspection.12/30/2013 Same as last inspection.7/29/2013 Same as last inspection. FIELD_STRUCT_DESC: *ABANDONED* 8-inch asphalt coated steel irrigation pipe through the levee, 4 feet below the crown. Pump on the waterside (WS) bank. Gate valve in a concrete pipe riser on the WS shoulder. (Permit No. 4091, 1962 - Halsey, Yerxa). [Additional Reference(s): DWR Levee Log, 2002]. FS Date: 4/26/2017 1:30:30 PM

Waterside view: abandoned pump station.

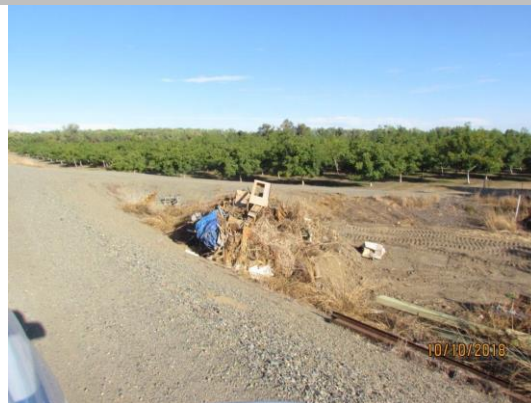
Photo 1 of 1 : SP_2019_ST0003_264_87_20190327_00019.jpg

LM Start	5.42	Rating **	M	Issue No.	87
LM End	5.42	Issue Type +	En	Location *	LS
Category	Earthen Levee			GPS Latitude/Longitude	
				Start	End
Item	Encroachments			39.217017 °	39.217017 °
				-122.003527 °	-122.003527 °
DWR ID	DWR_ST0003_01_f_2018_87				
Comment Code					
DE : Debris					
Inspector Comment					
Remove the prunings and garbage from the landside toe.

View of the prunings and garbage along the landside toe.

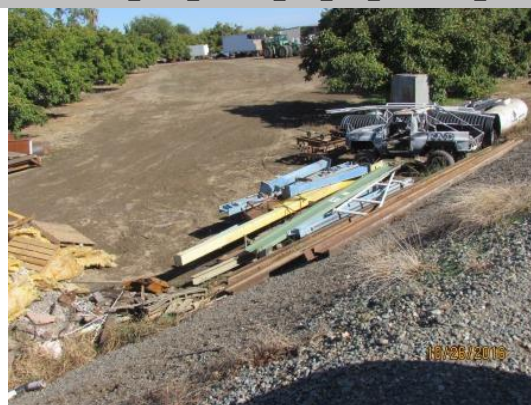
Photo 1 of 1 : SP_2019_ST0003_264_100_20190327_00025.jpg

LM Start	5.42	Rating **	M	Issue No.	100
LM End	5.42	Issue Type +	En	Location *	LS
Category	Earthen Levee			GPS Latitude/Longitude	
				Start	End
Item	Encroachments			39.217047 °	39.217047 °
				-122.003632 °	-122.003632 °
DWR ID	DWR_ST0003_01_s_2019_100				
Comment Code					
EQ : Equipment					
Inspector Comment					
Equipment and materials should be removed from the landside toe.

View of the ag equipment along the landside toe.
